N61165.AR.003140
CNC CHARLESTON
5090.3a

TECHNICAL MEMORANDUM SUMMARY OF FINDINGS FOR BUILDING 177 WASTE
MATERIAL INSPECTION CNC CHARLESTON SC
8/27/2013
RESOLUTION CONSULTANTS

Date: August 27, 2013
To: Mr. Art Sanford, BRAC Southeast
From: Mr. Shawn Dolan, P.G., Resolution Consultants –Project Manager
Subject: Summary of Findings – Building 177 Waste Material Inspection
Former Charleston Naval Shipyard

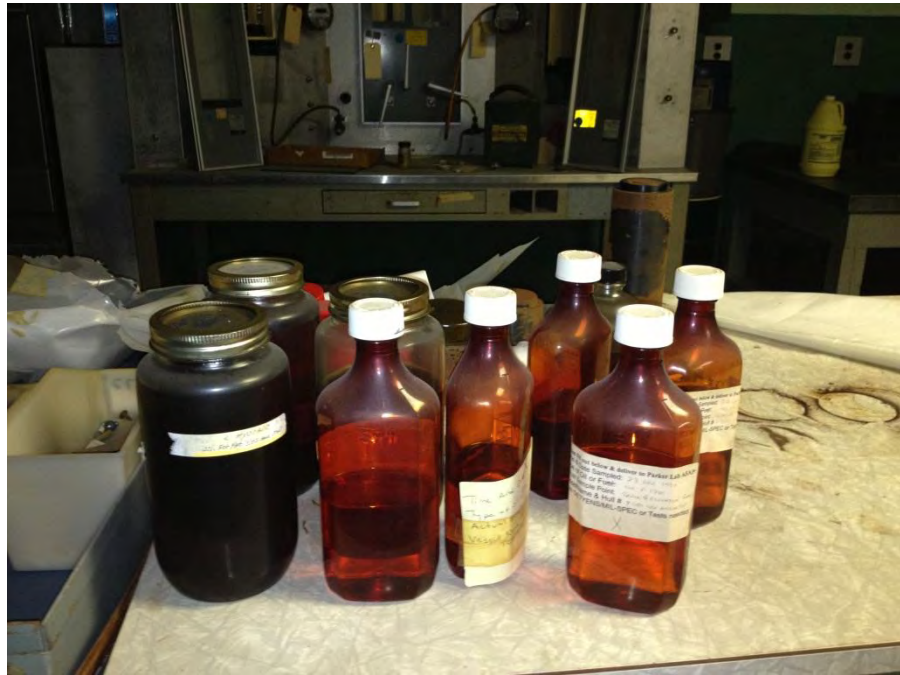
- Several sample bottles dated December 1997 and labeled “Detyens”. These sample bottles each contain what appears to be oil (Photos 1 and 2, Attachment B).
- A FedEx envelope, dated April 1998, delivered to “Applied Technical Services, 1865 Avenue B North, Building 177” (Photo 3, Attachment B).
- A mercury vault, approximately 2ft x 2ft x 2ft, labeled “Use approved by NAVSEA” (Photos 4 through 6, Attachment B).
- Additional ownership/user information was noted in a photo provided by Dentyens personnel. A 30 gallon container of Fryquel, located on the 4th floor, was labeled “Applied Technical Services, Inc., Cross County Road, N. Charleston, SC 29418” (Photos 28 and 29, Attachment B).

Sample bottles left on table in lab, dated December 1997 and labeled "DETYENS". Close up view of label is provided in Photo 2 (below).

Does not appear to be related to Navy activities.

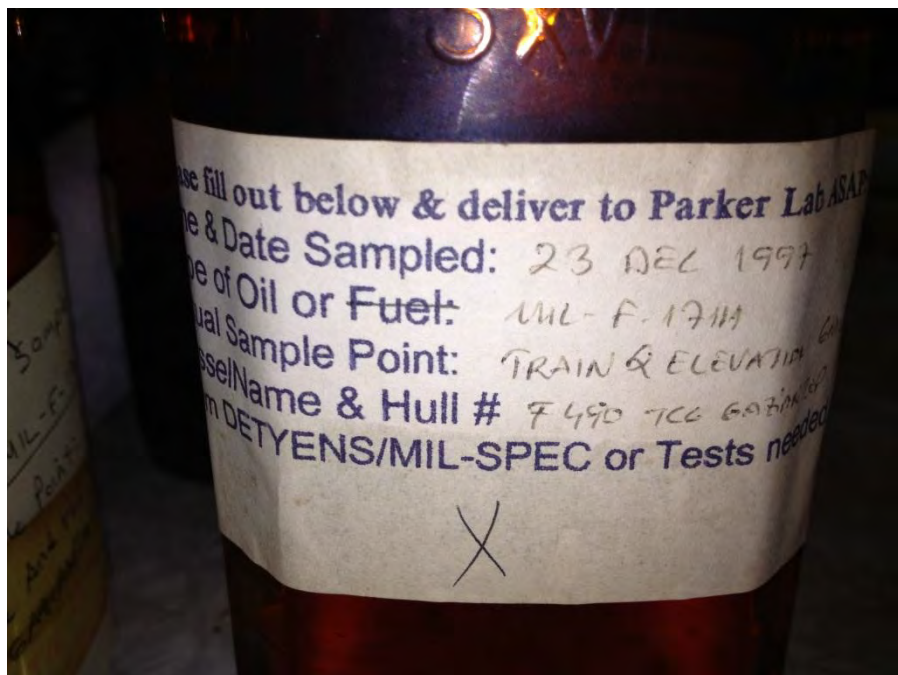
2

Sample bottle labeled "DETYENS"

Does not appear to be related to Navy activities.

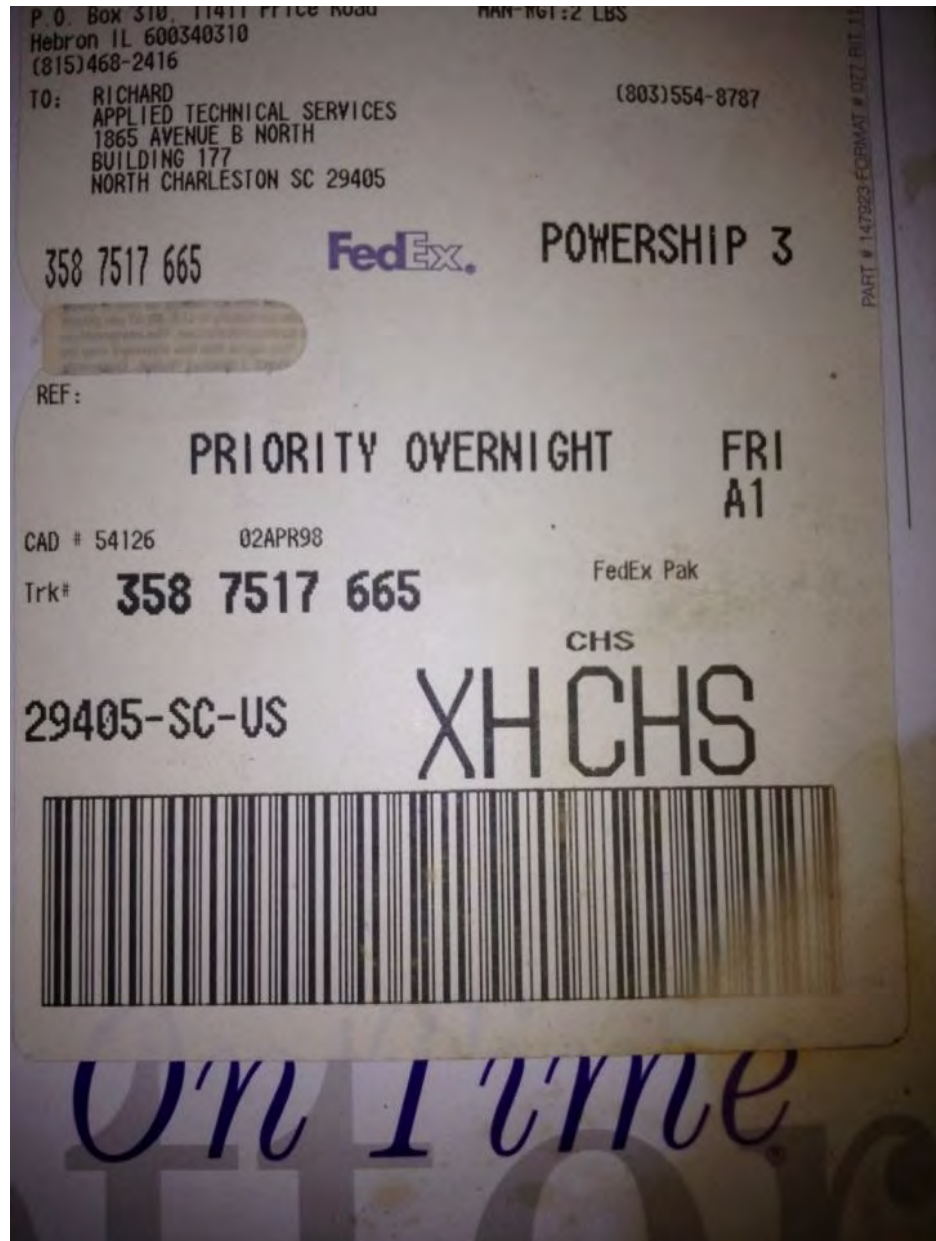
3

FedEx Pack, dated April 1998, found in lab room in Building 177, 2ND floor.

Recipient is "Applied Technical Services, 1865 Avenue B North, Building 177"

This label indicates that **the most recent use of the lab room was potentially not related to Navy activities.**

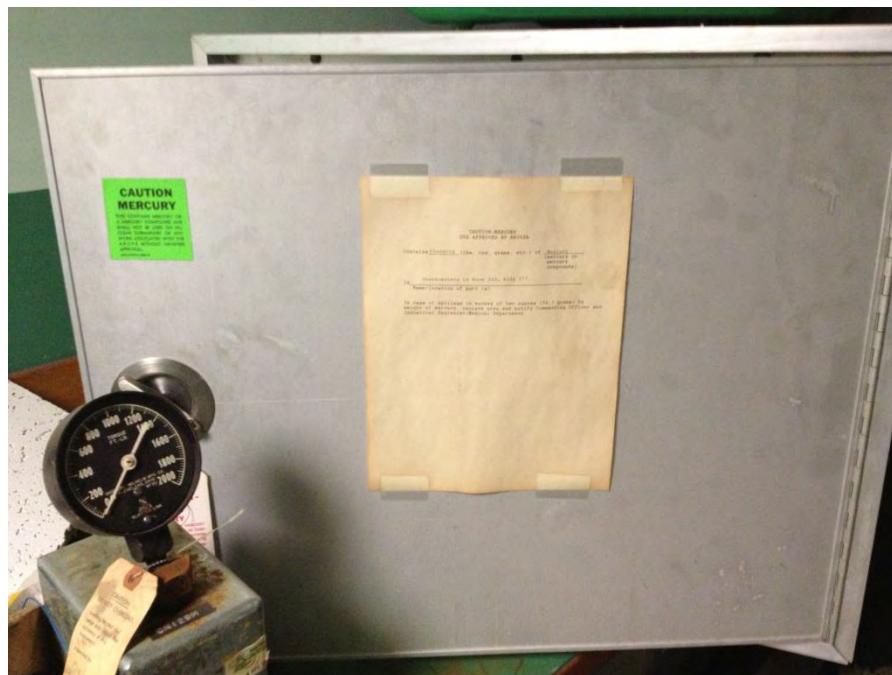
4

Mercury vault.

Label reads,
"CAUTION
MERCURY."2nd Floor lab room.Based on the label
shown in photo
number 5 (below),
this container
**appears to be
related to Navy
activities.**However, it is not
known whether
any material
remains inside the
container.

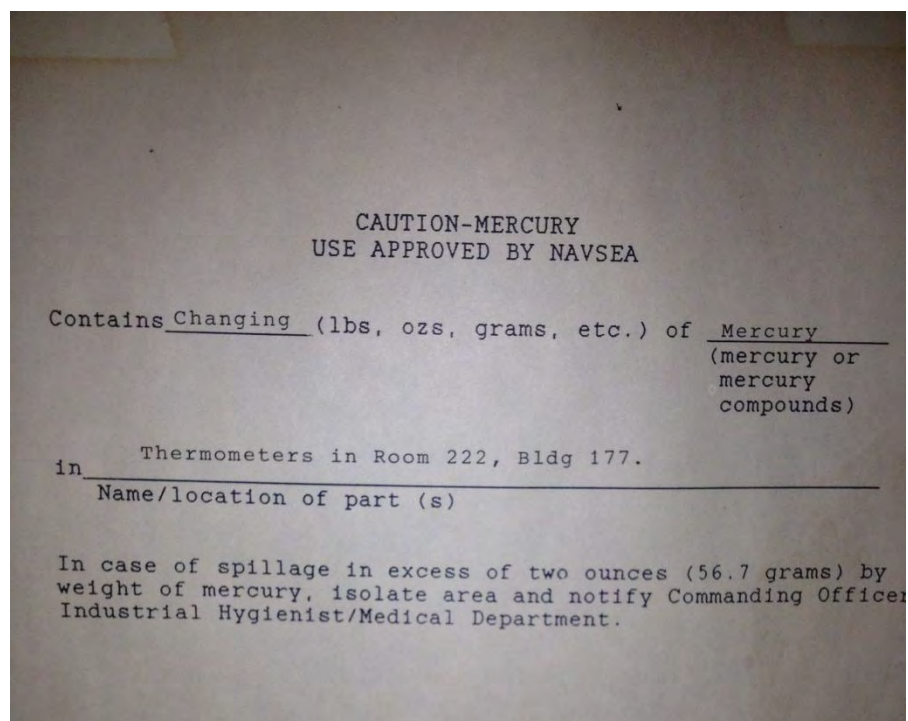
5

Description:Notice posted on
mercury vault.2nd Floor lab room.

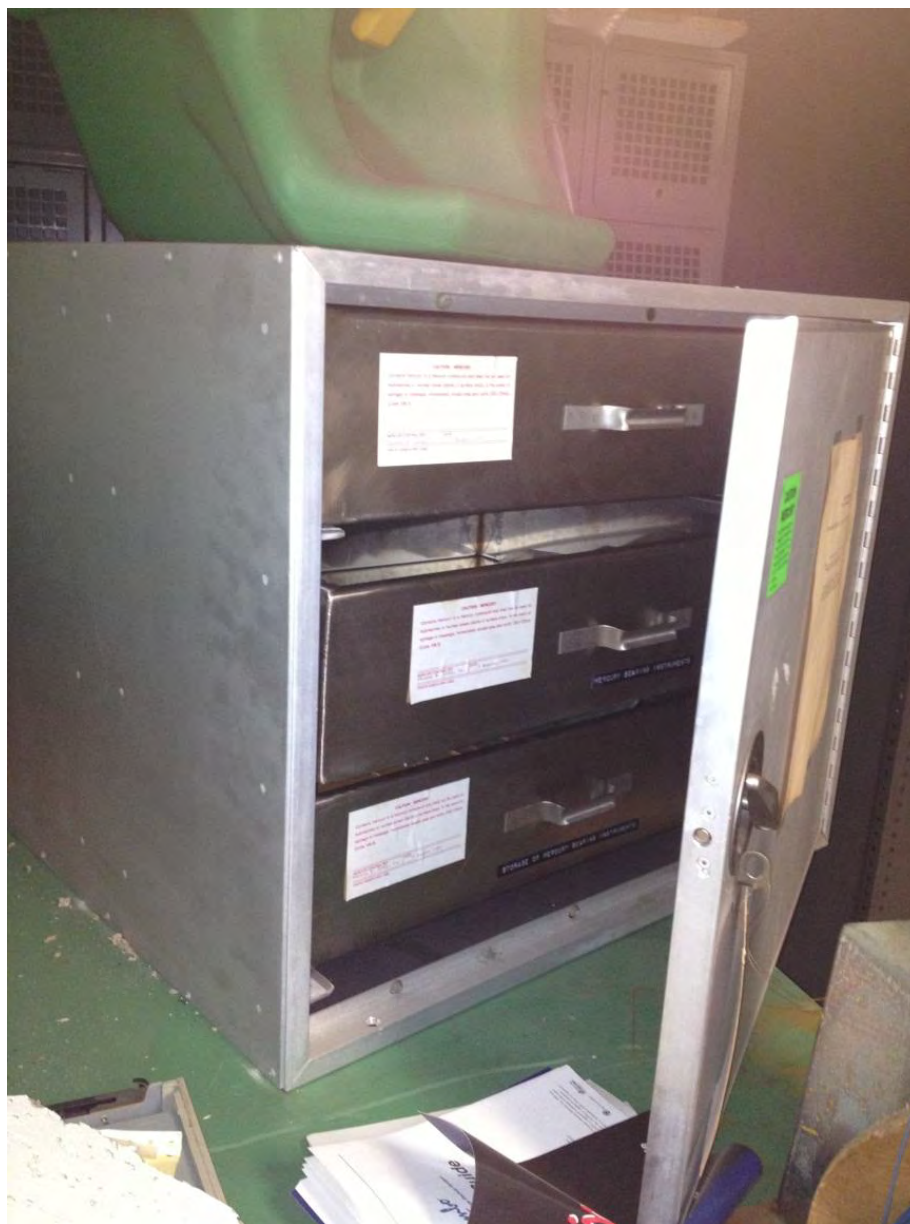
6

Inside of Mercury vault.

Drawers labeled
"Storage of
Mercury bearing
instruments".

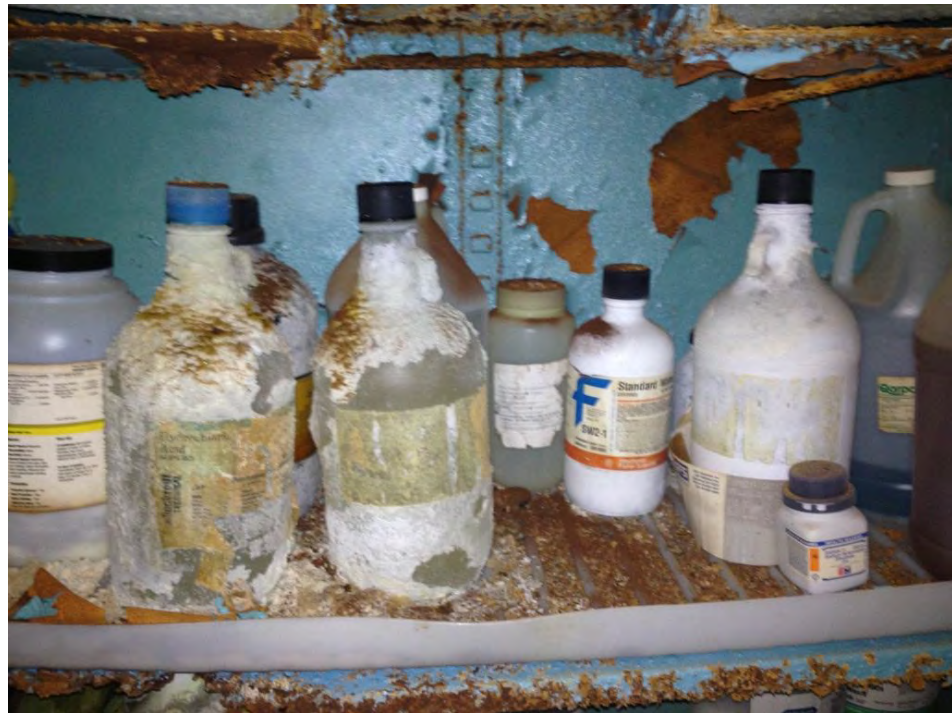
- A corrosive locker, approximately 4ft x 3ft x 2ft, located in the 2nd floor laboratory contained numerous containers in what appears to be unstable condition (Photos 7 through 17, Attachment B). Chemical identifying labels were visible on each container, however, there was no recipient information on the containers so ownership of the wastes could not be determined.

2nd Floor lab room
- Corrosive storage cabinet.

There are no shipper markings on this container; therefore, it is **undetermined whether this material is related to Navy activities.**

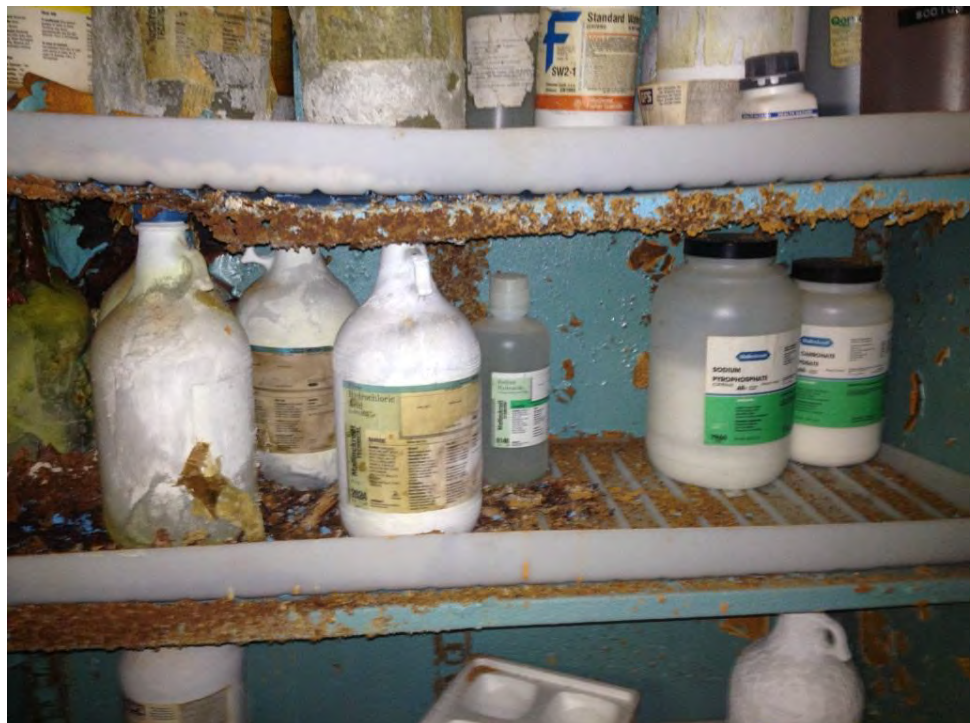
8

Chemicals stored in cabinet, including Hydrochloric Acid, Sodium Hydroxide, and Sodium Pyrophosphate.

There are no shipper markings on this container; therefore, it is **undetermined whether this material is related to Navy activities.**

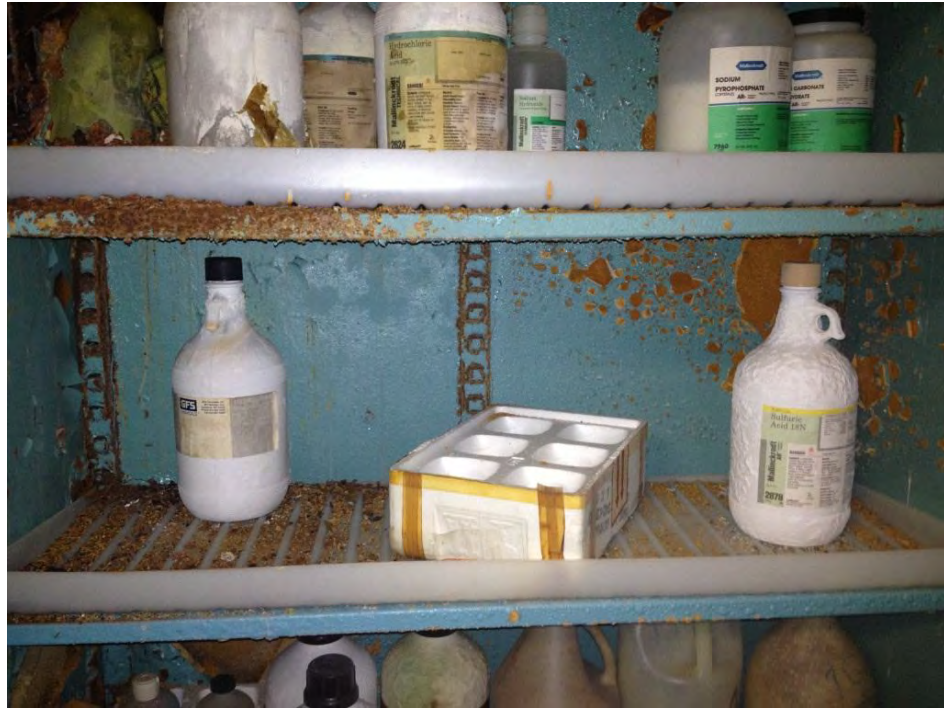
9

Chemicals stored in cabinet, including Sulfuric Acid.

There are no shipper markings on this container; therefore, it is **undetermined whether this material is related to Navy activities.**

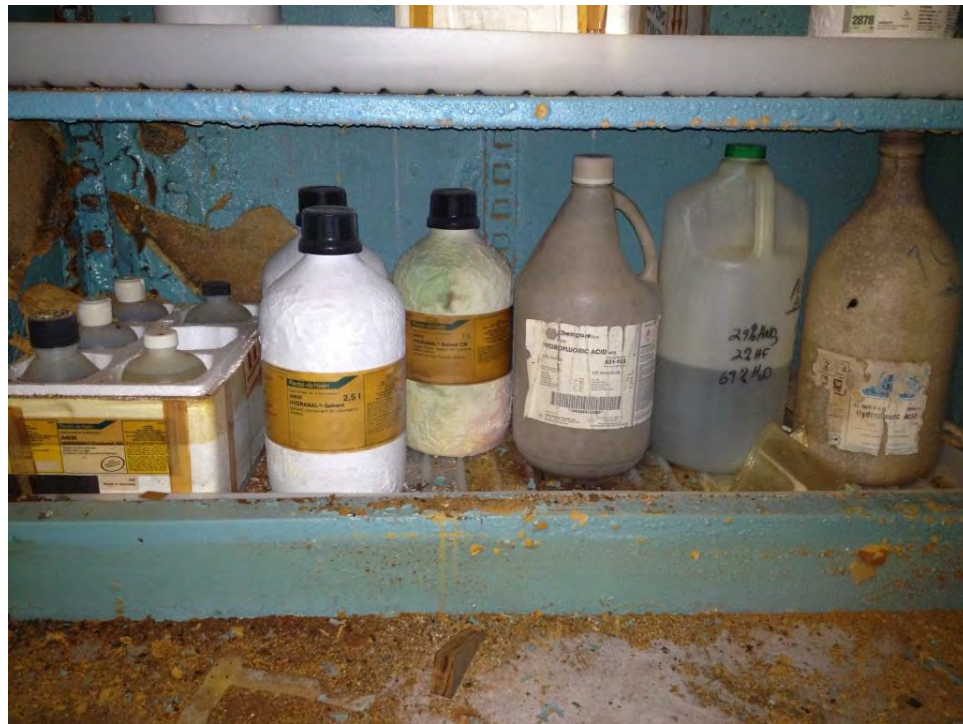
10

Chemicals stored in cabinet, including Hydrofluoric Acid and Hydranal® Solvent.

There are no shipper markings on this container; therefore, it is **undetermined whether this material is related to Navy activities.**

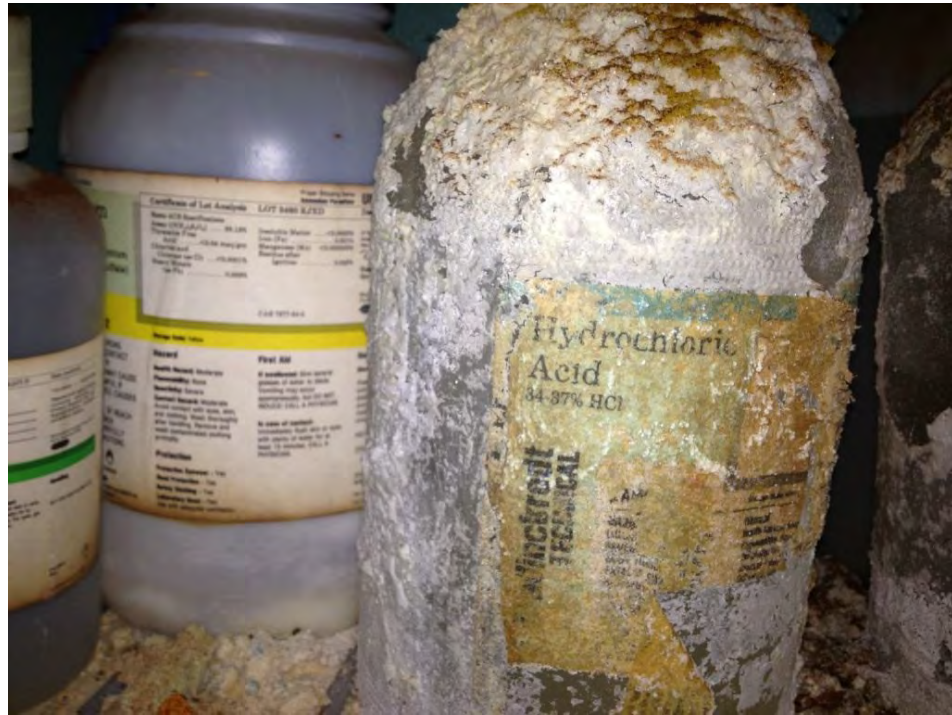
11

Crystallized
Hydrochloric Acid.

There are no
shipper markings
on this container;
therefore, it is
**undetermined
whether this
material is related
to Navy activities.**

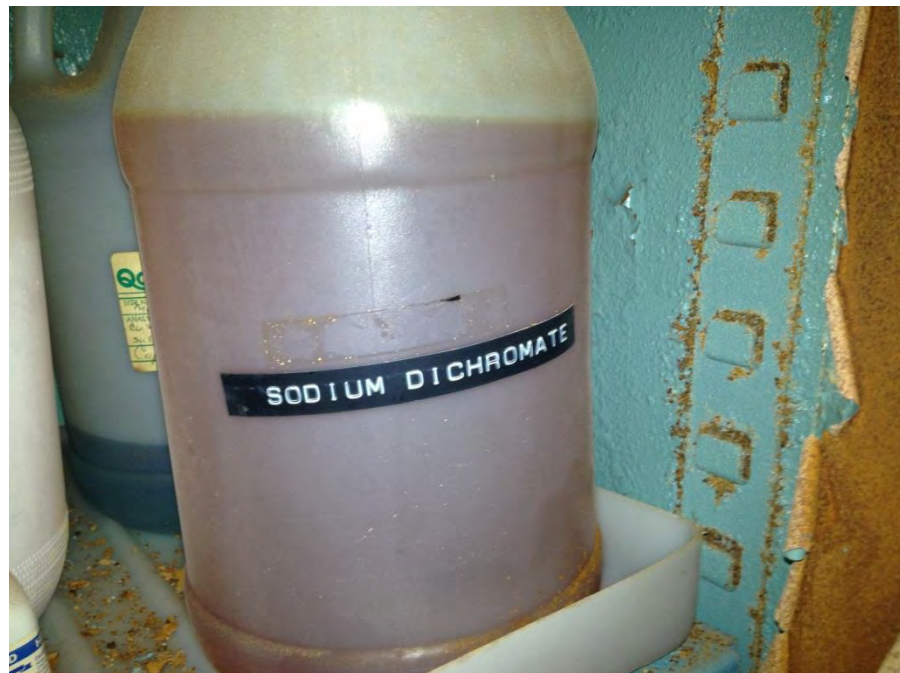
12

Chemicals stored
in cabinet,
including Sodium
Dichromate and
Copper Sulphate.

There are no
shipper markings
on this container;
therefore, it is
**undetermined
whether this
material is related
to Navy activities.**

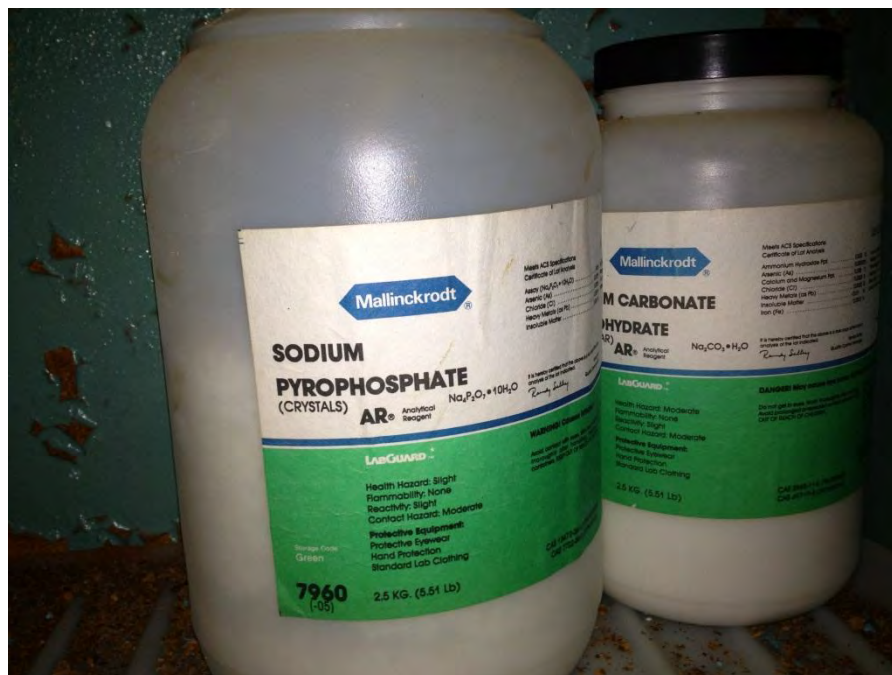
13

Sodium Phosphate crystals and Sodium Carbonate Hydrate.

There are no shipper markings on this container; therefore, it is **undetermined whether this material is related to Navy activities.**

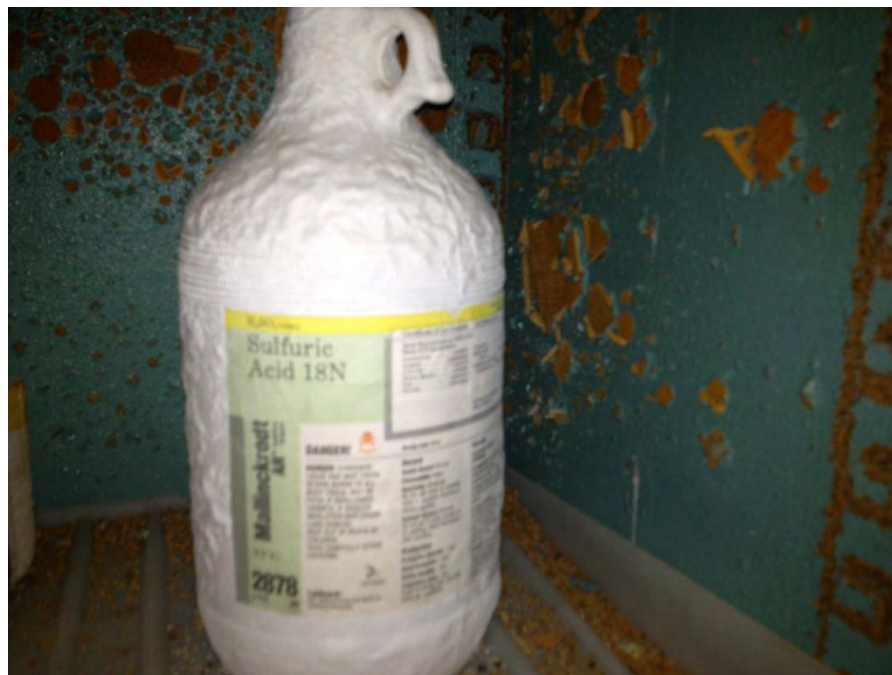
14

Sulfuric Acid.

There are no shipper markings on this container; therefore, it is **undetermined whether this material is related to Navy activities.**

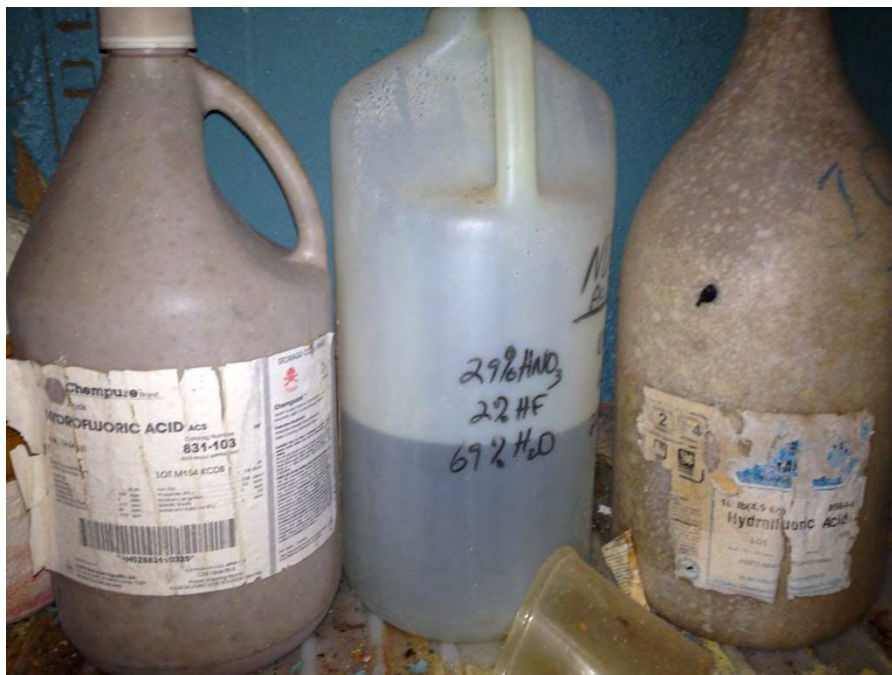
15

Chemicals stored in cabinet, including Hydrofluoric Acid and a Nitric Acid mixture.

There are no shipper markings on this container; therefore, it is **undetermined whether this material is related to Navy activities.**

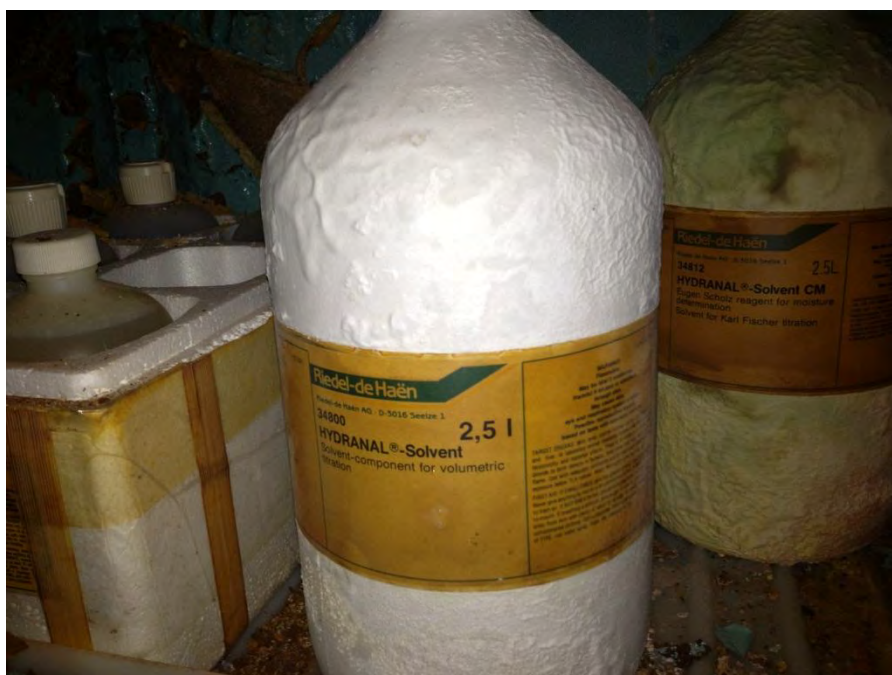
16

Hydranal® Solvent.

There are no shipper markings on this container; therefore, it is **undetermined whether this material is related to Navy activities.**

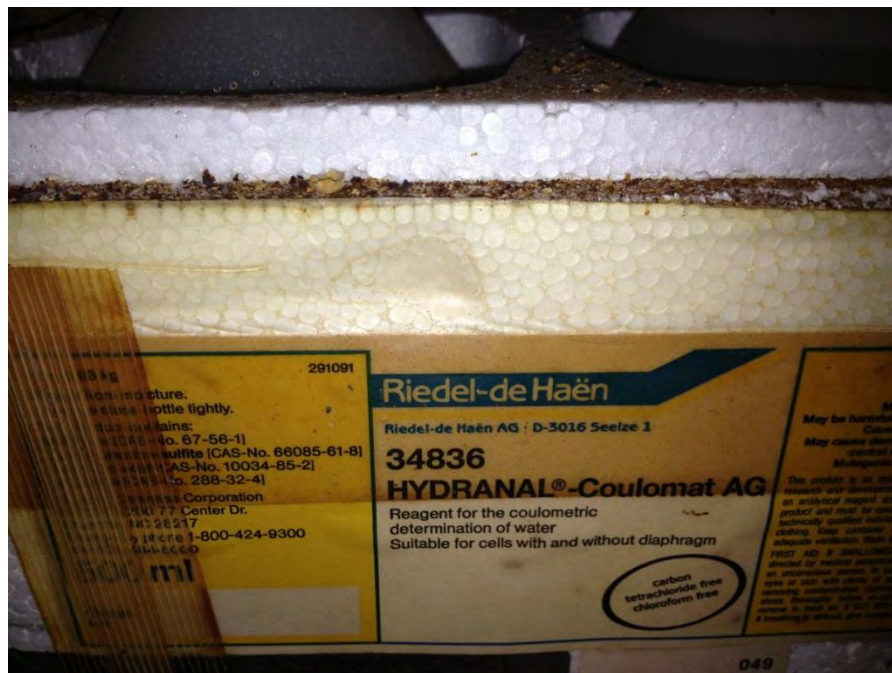
17

Hydranal®
Solvent.

There are no shipper markings on this container; therefore, it is **undetermined whether this material is related to Navy activities.**

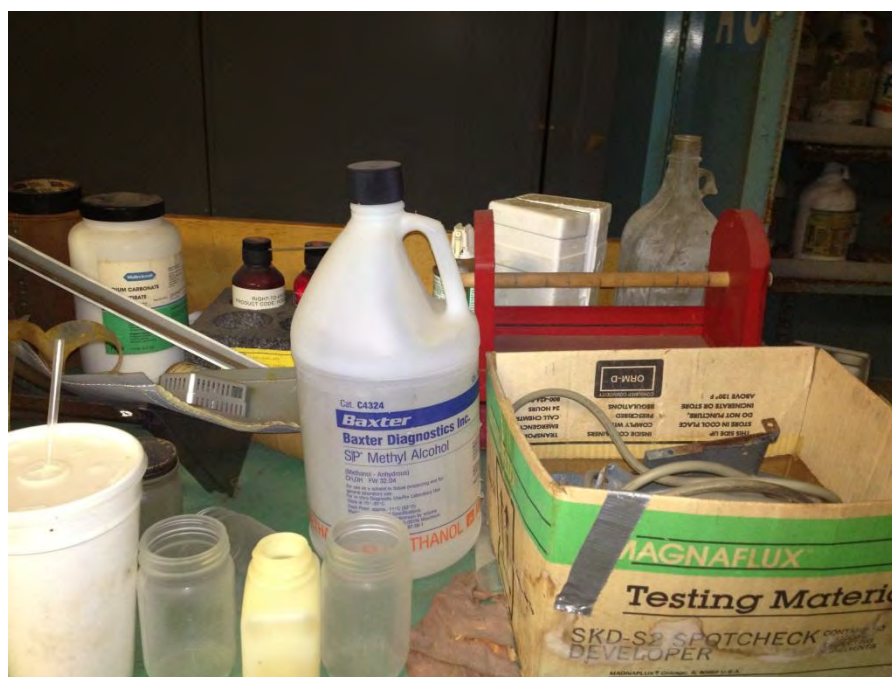
18

Table containing miscellaneous items including Methyl Alcohol and Sodium Carbonate.

There are no shipper markings on this container; therefore, it is **undetermined whether this material is related to Navy activities.**

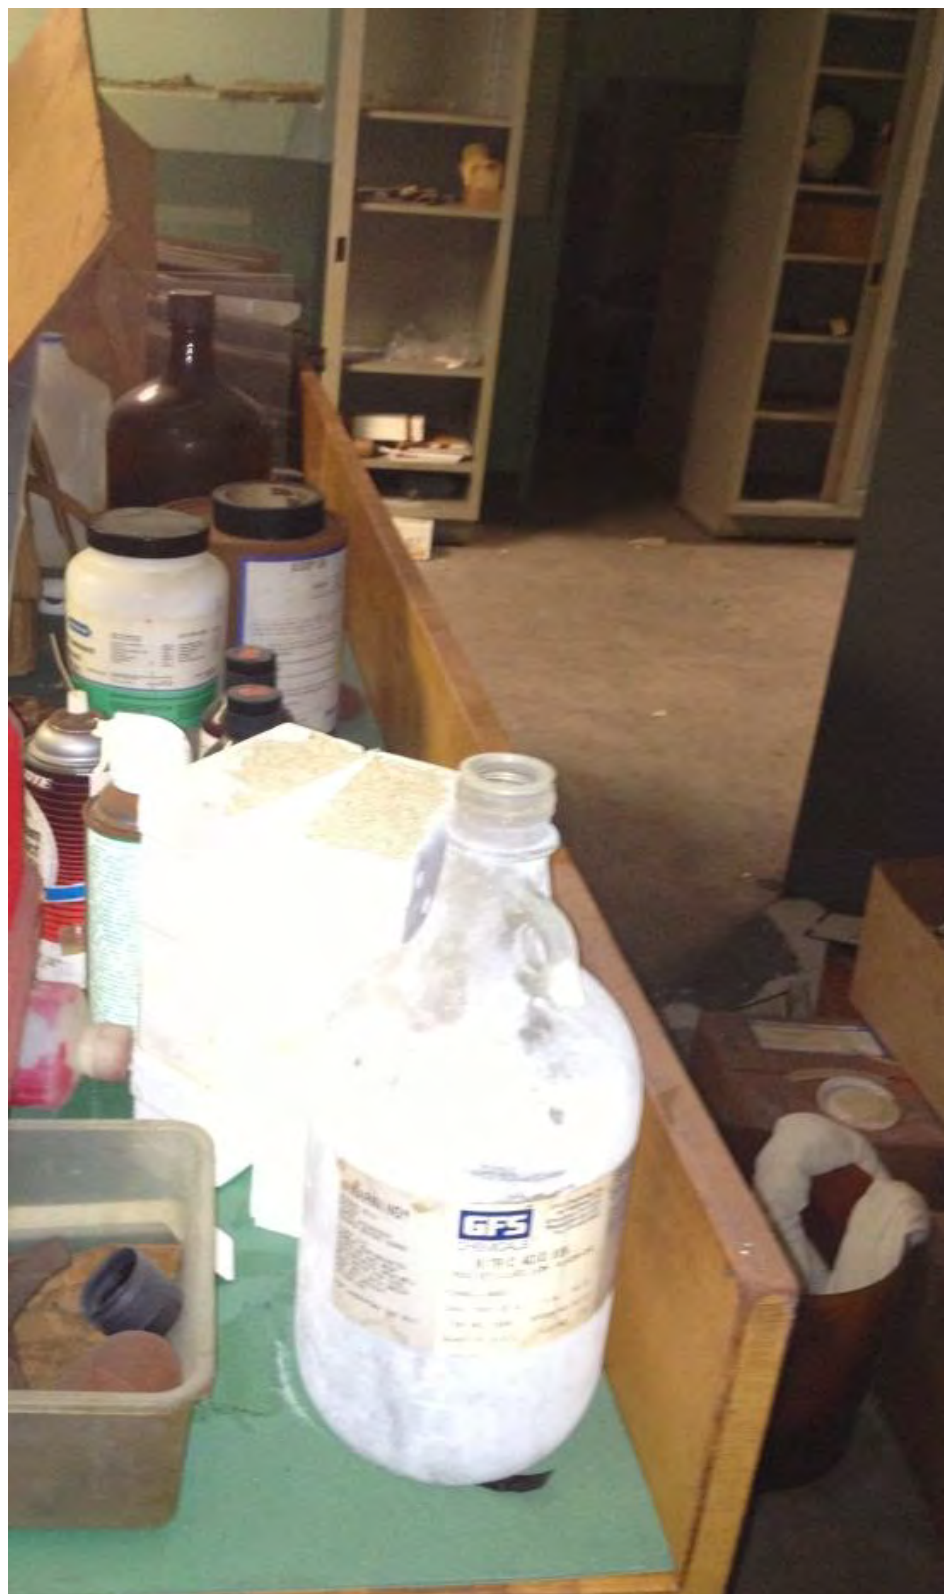
19

Table containing miscellaneous items including Nitric Acid and Sodium Carbonate.

There are no shipper markings on this container; therefore, it is **undetermined whether this material is related to Navy activities.**

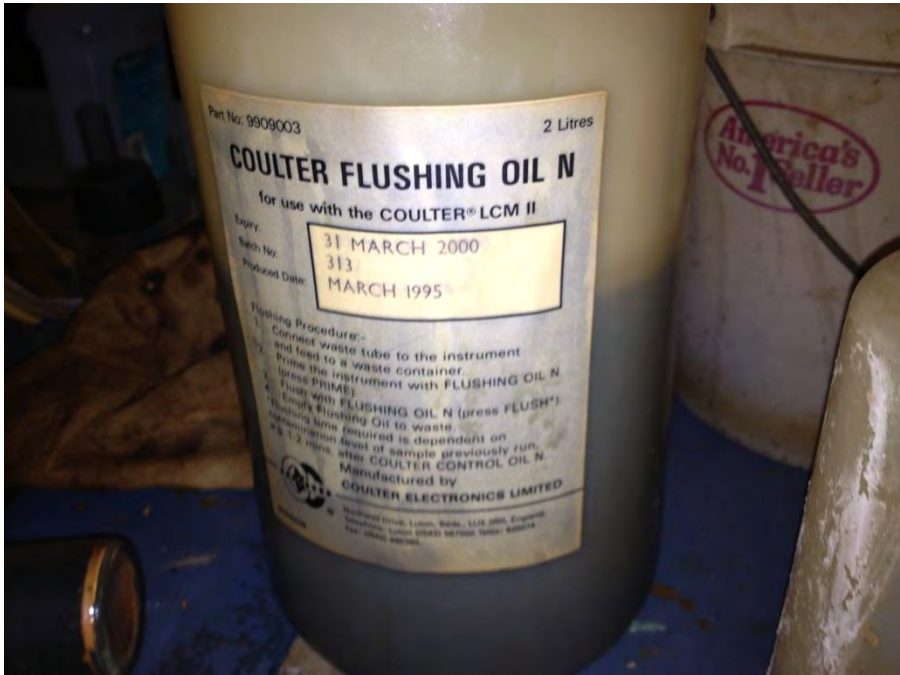
<p>Photo Number: 20</p> <p>Description: “Coulter Flushing Oil” Expiry: 31 March 2000 Produced Date: March 1995 2nd Floor lab room There are no shipper markings on this container; therefore, it is undetermined whether this material is related to Navy activities.</p>

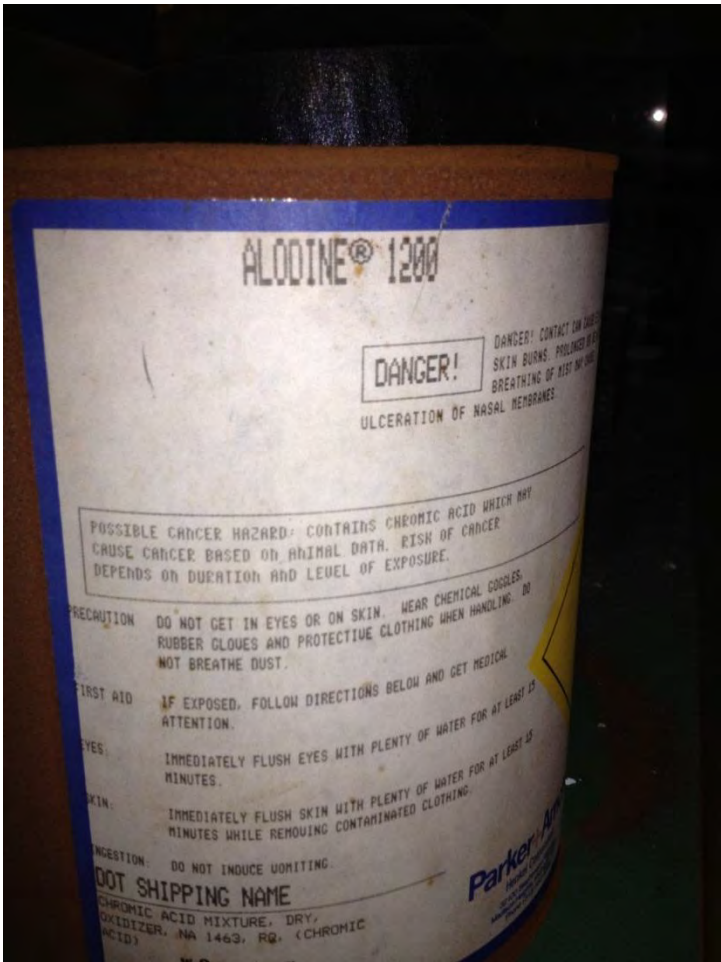
<p>Photo Number: 21</p> <p>Description: Alodine ® 1200 Label reads, “Danger!” Possible cancer hazard: contains Chromic Acid which may cause cancer based on animal data. Risk of cancer depends on duration and level of exposure.” 2nd Floor lab room There are no shipper markings on this container; therefore, it is undetermined whether this material is related to Navy activities.</p>

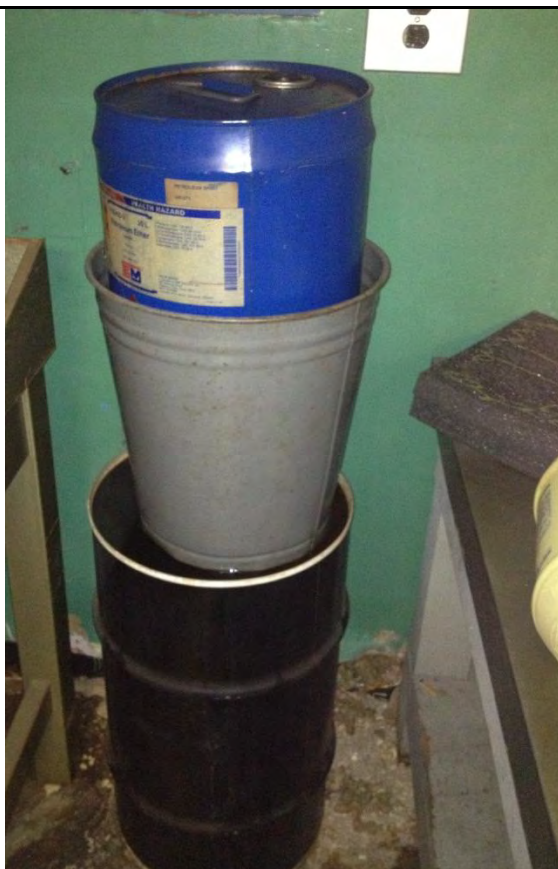
- A 5-gallon drum labeled “Petroleum Ether” was observed in the laboratory, in which the contents apparently have leaked from the drum. The drum had no recipient information on the containers so ownership of the wastes could not be determined (Photos 22 and 23, Attachment B).

5 gallon bucket
labeled "Petroleum
Ether" (leaking).
Close up view of
label is provided in
Photo 23 (below).

There are no
shipper markings
on this container;
therefore, it is
**undetermined
whether this
material is related
to Navy activities.**

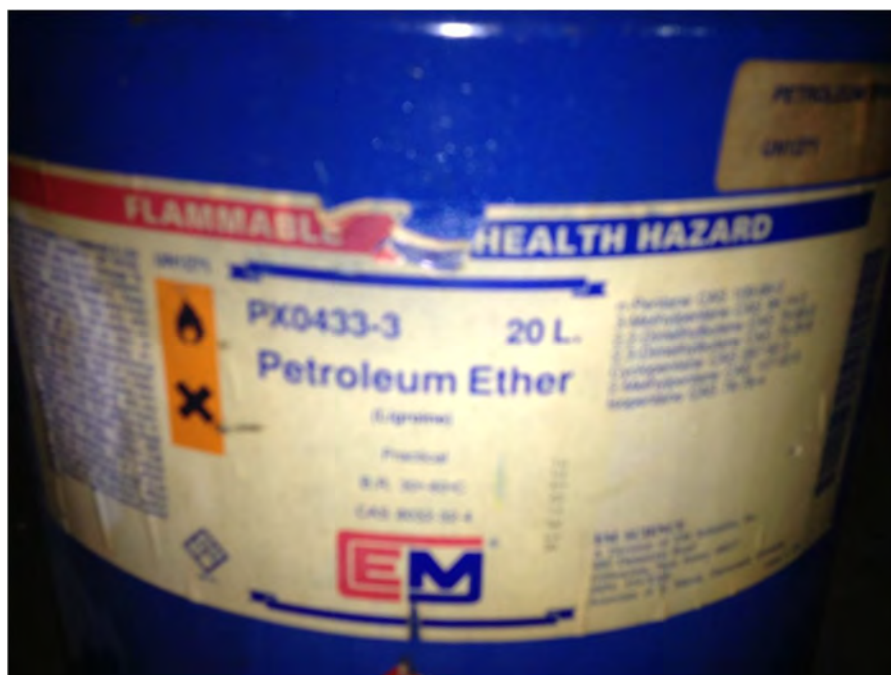
23

Close up view of
Petroleum Ether
bucket.

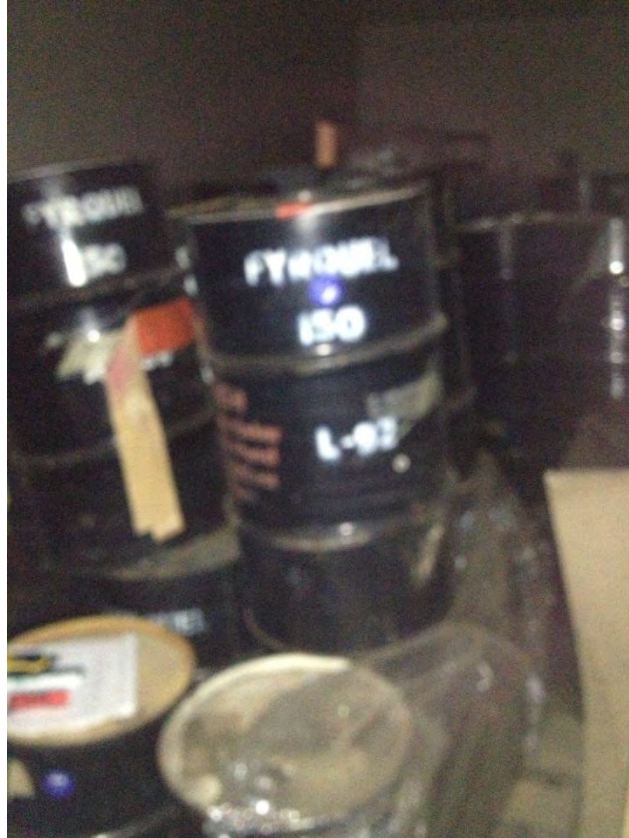
- The 30 gallon containers located in the storage room on the 2nd floor appear to be empty. Detyens personnel indicated that they would conduct a more thorough inventory of these waste containers and report back to the Navy. However, these 30 gallon containers are similar to the container of Fryquel, located on the 4th floor and are not likely the former property of the Navy (Photos 24 through 26, Attachment B).

30 gallon drums labeled "Fyrquel 150" / "Phosphate Ester" / "Waste Oil".

Approximately 50 drums total. All drums appear to be empty.

If all the drums are empty, **this would not be considered a waste material.**

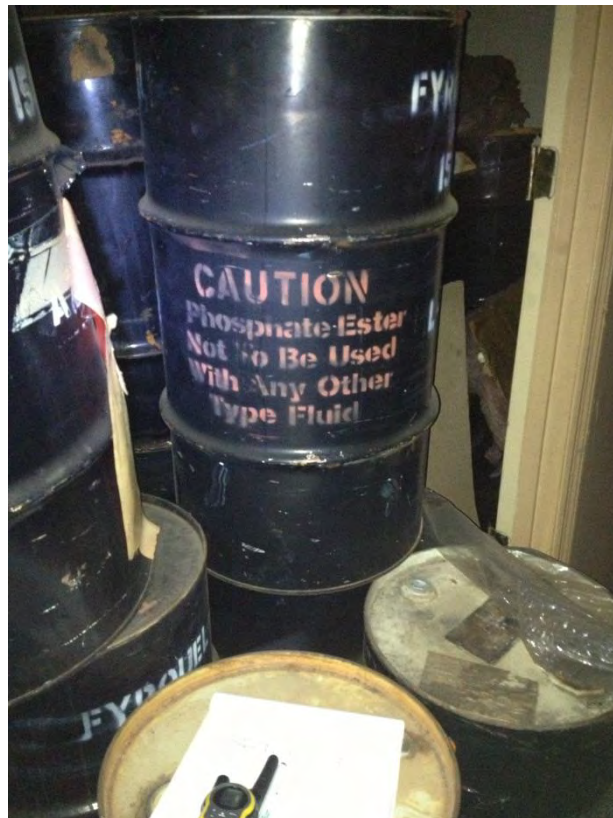
25

Empty 30 gallon drum labeled Phosphate Ester.

If all the drums are empty, **this would not be considered a waste material.**

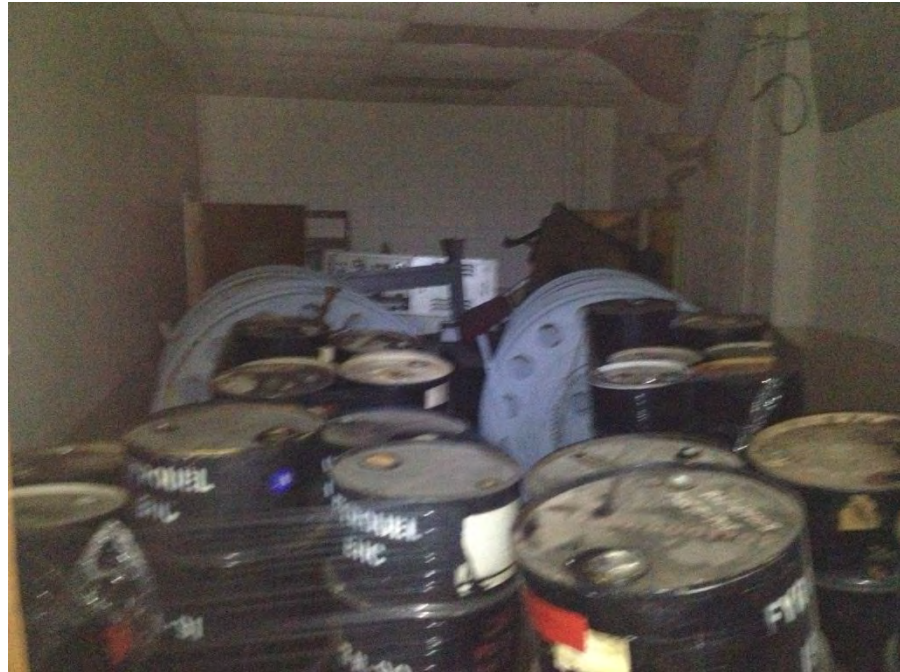
26

30 gallon drums of
Fyrquel 150 /
Phosphate Ester /
Waste Oil.
Approximately 50.
Some may be
empty.

If all the drums are
empty, **this would
not be considered
a waste material.**

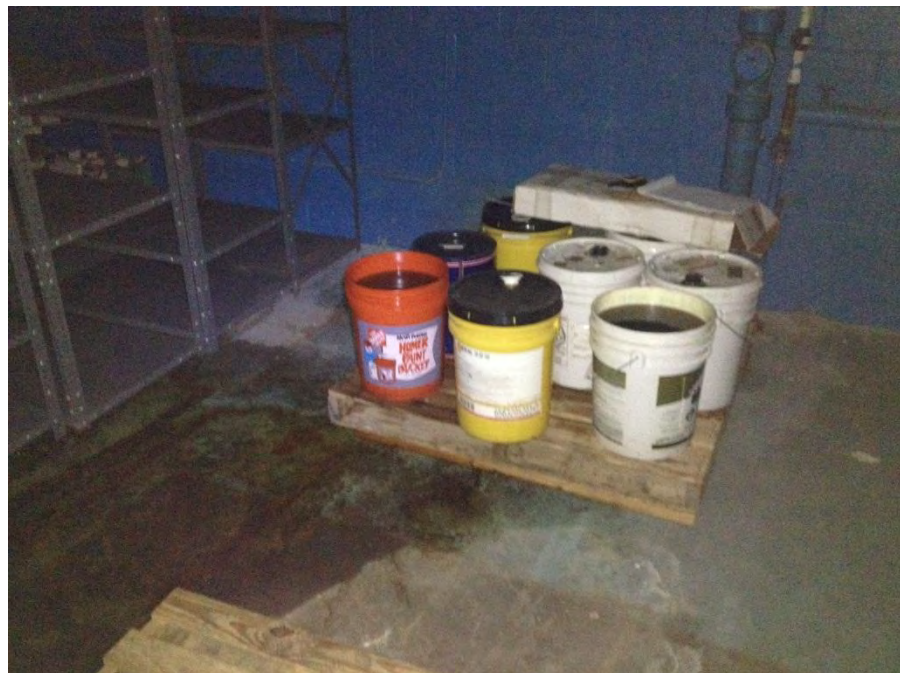
27

Pallet of eight 5
gallon buckets of
Antifreeze /
Guildline / Acrylic
Lacquer Thinner /
Morlina Oil SD
150

Photo provided by
Detyens personnel.
Resolution
Consultants was
not escorted to this
location, however,
based on the
observed
conditions of the
buckets and the
time of the Navy's
departure from the
building (~1995),
**this material does
not appear to be
related to Navy
activities.**

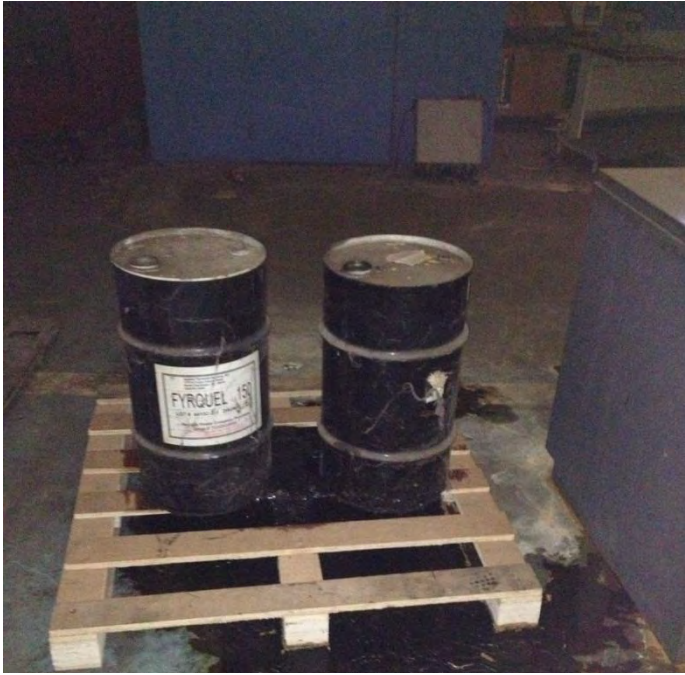
<p>Photo Number: 28</p> <p>Description: Two 30 gallon drums of Fyrquel 150 (leaking). 4th Floor. Photo provided by Detyens personnel. Resolution Consultants was not escorted to this location, however, based on the label shown in photo number 12 (below), this material does not appear to be related to Navy activities.</p>

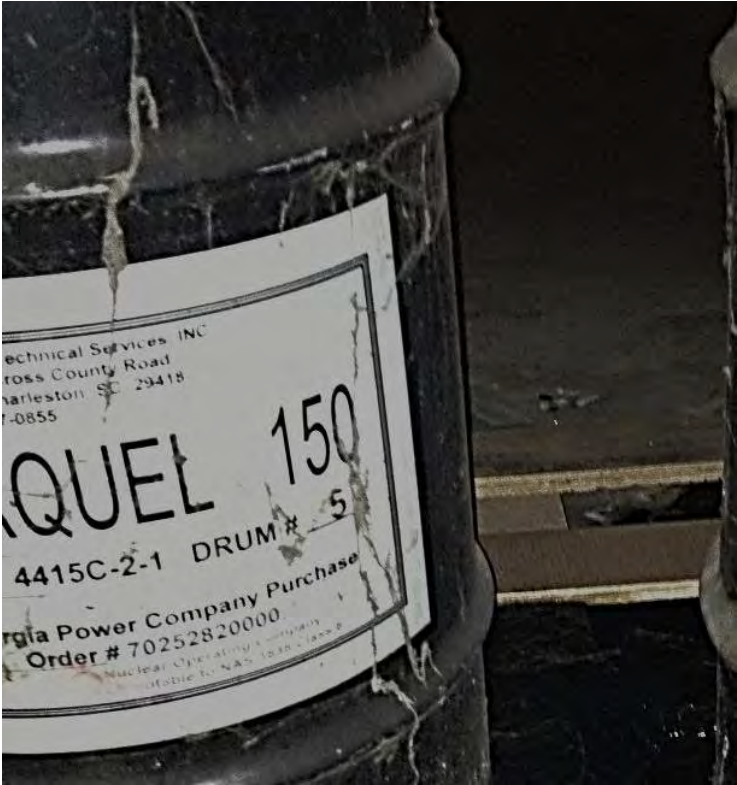
<p>A photograph showing two dark-colored 30-gallon drums sitting on a wooden pallet. The drum on the left has a white label with 'FYRQUEL 150' printed on it. The drums are in a dimly lit industrial setting.</p>
<p>Photo Number: 29</p> <p>Description: Label from leaking Fyrquel 150 drum. Label reads, "Applied Technical Services, Inc., Cross County Road, N. Charleston, SC 29418 29418 Fyrquel 150 Georgia Power Company Purchase 4th Floor Storage. This material does not appear to be related to Navy activities.</p>

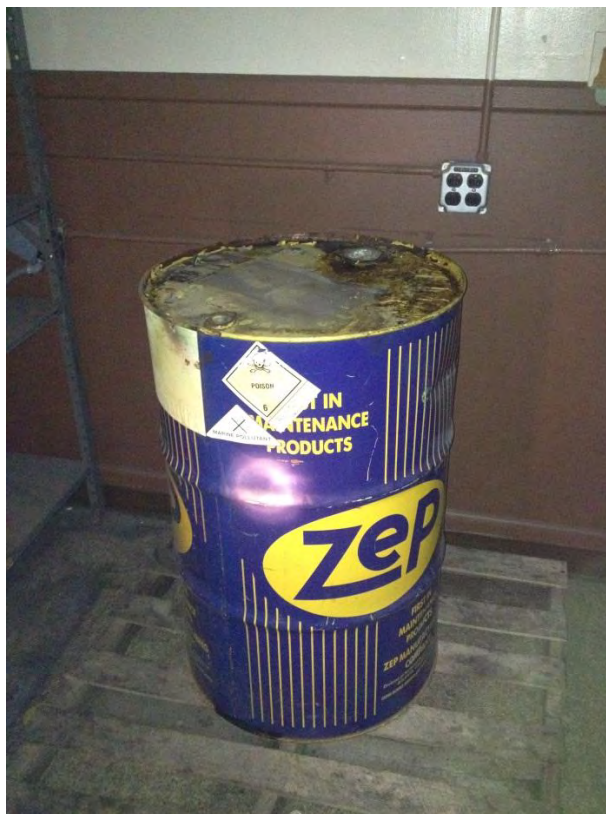
30

55 gallon drum of
ZEP.

Resolution
Consultants was
not escorted to this
location, however,
based on the
observed
conditions of the
drum in the photo
**this material does
not appear to be
related to Navy
activities.**
